**SITE DESCRIPTION/ SUITABILITY ASSESSMENT (SD/SA) REPORT**

**SOLAR PHOTO-VOLTAIC SYSTEM/ POWER PURCHASE  
AGREEMENT FOR FORT INDIANTOWN GAP  
ANNVILLE, PENNSYLVANIA**

**GANFLEC**

**March 2015**

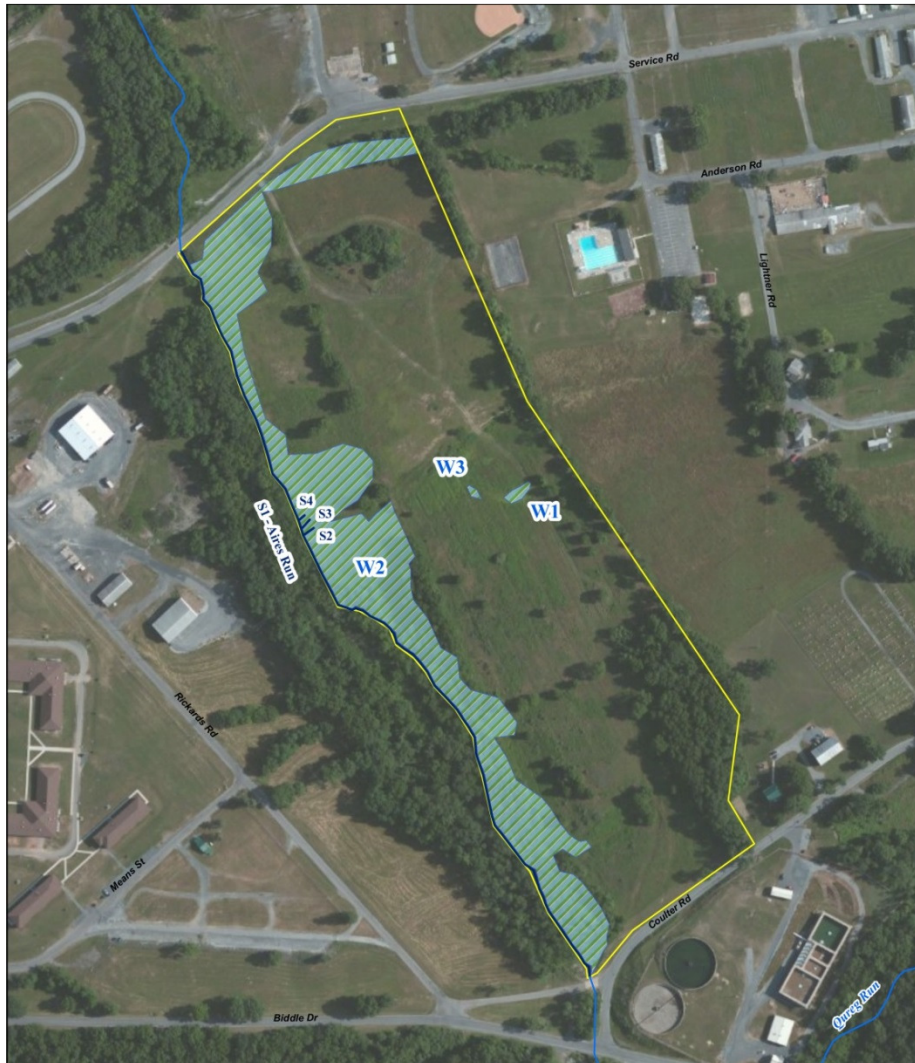
### Wetland Map

The major area of wetlands, within the site area, encompasses the floodplain area along Aires Run and extends along a drainage channel along the south side of Service Road. The wetlands along Aires Run primarily lie within existing wooded areas. There are also two small isolated wetland areas located within the central portion of the project site. For a detailed review of the performed testing and findings please see Attachment SDSA – 3 - “Wetland Report” attached to the end of this SD/SA report.

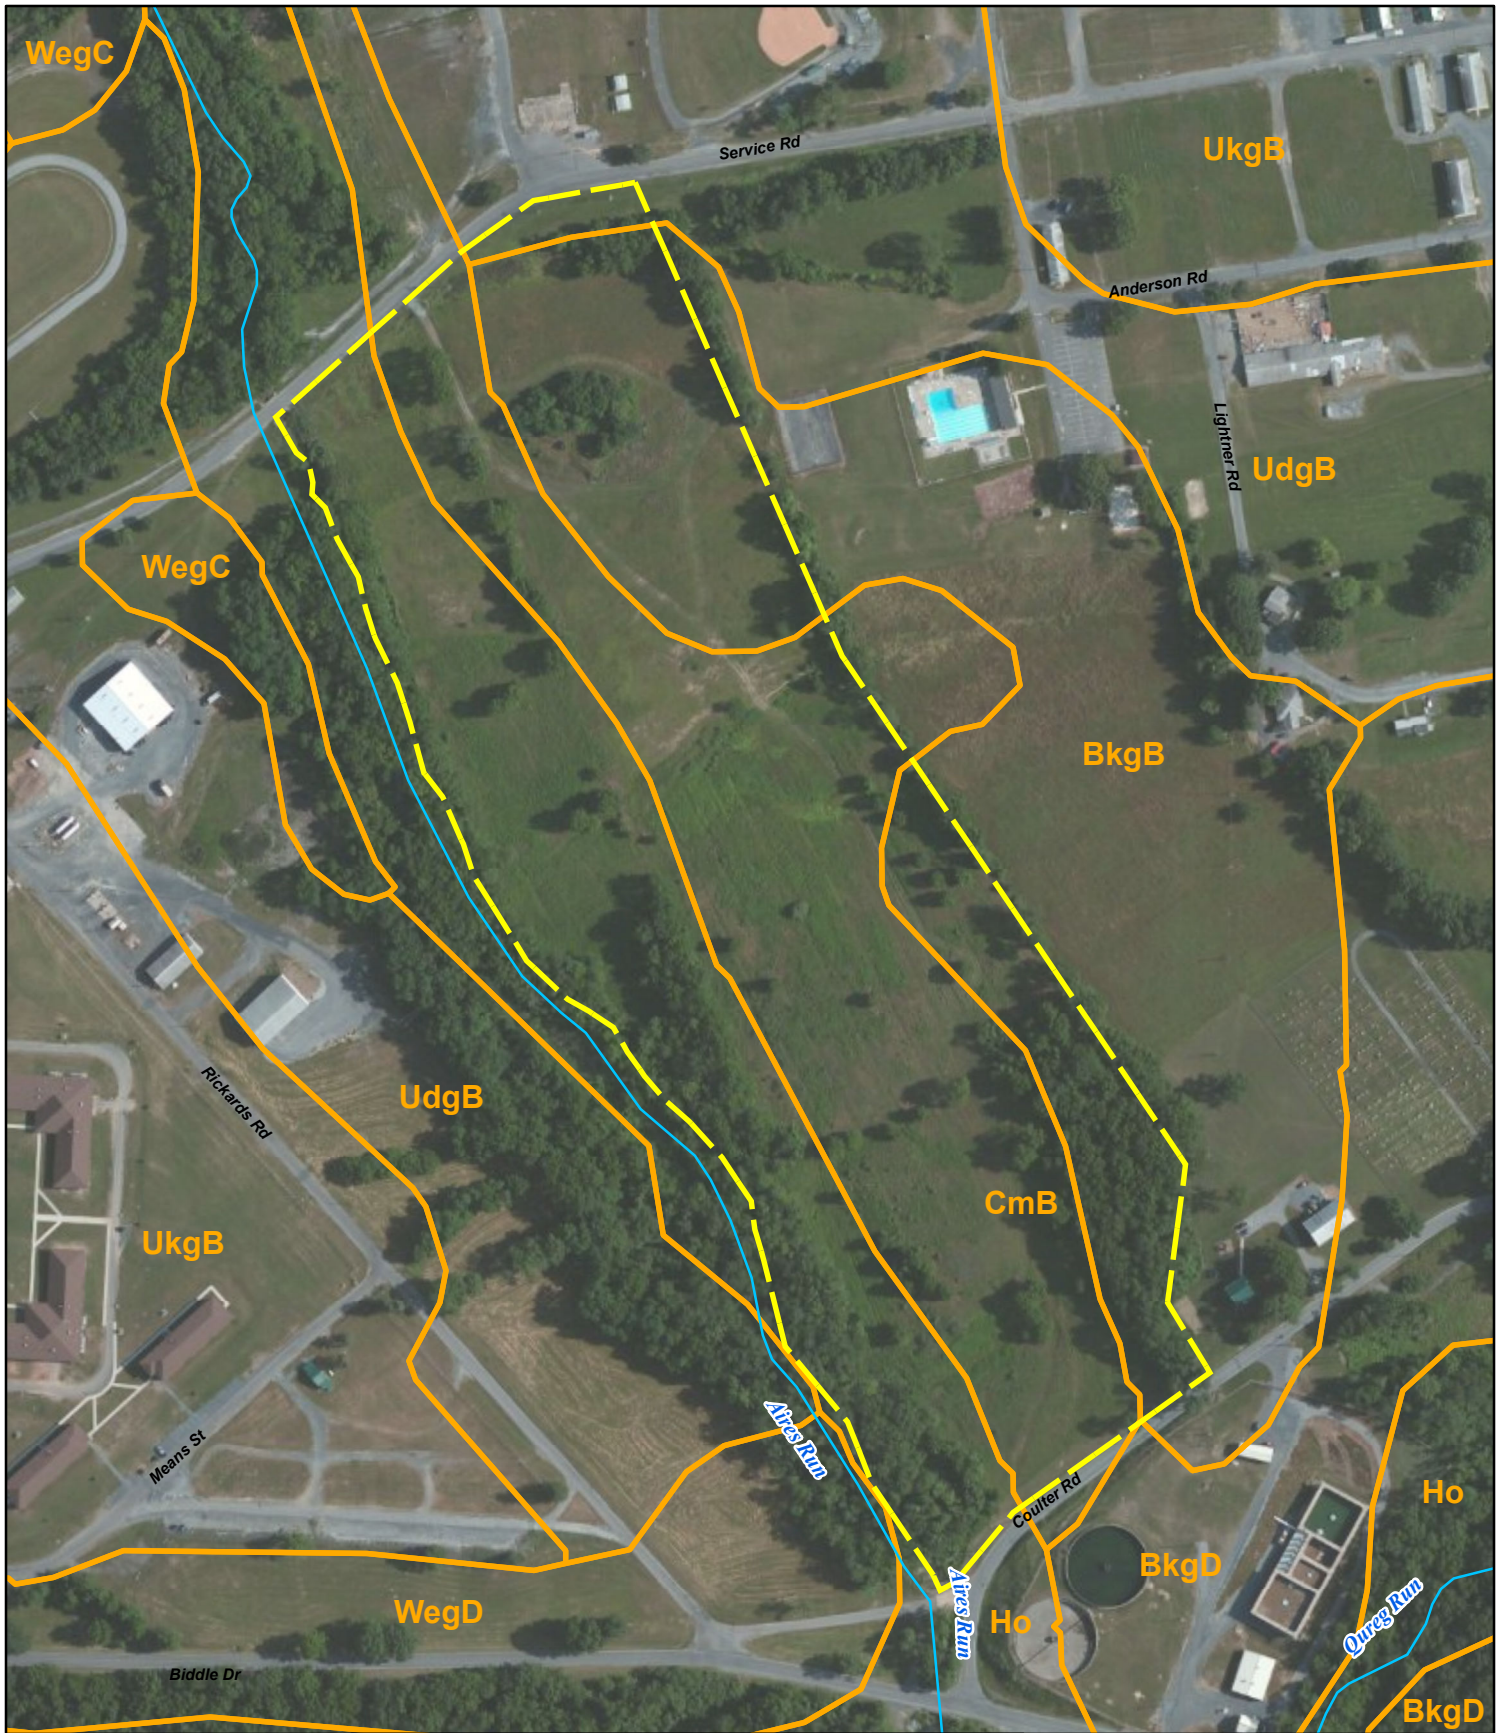
**Figure 3**  
**Lebanon County Soil Map**  
 Pennsylvania Air National Guard  
 Solar Farm  
 Service Road, Fort Indiantown Gap  
 Union Township, Lebanon County, Pennsylvania

### 3.2 Soils

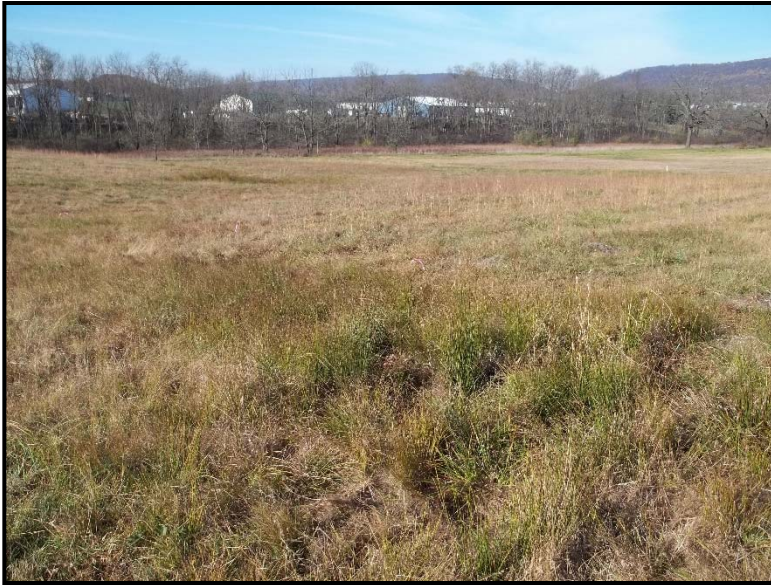
**Photo 1** (11-10-2014)

Wetland W1 is a palustrine emergent (PEM) wetland located in a depression surrounded by fallow field in the eastern portion of the project study area. Plot 1 is the hydric test plot for this wetland. View is west.

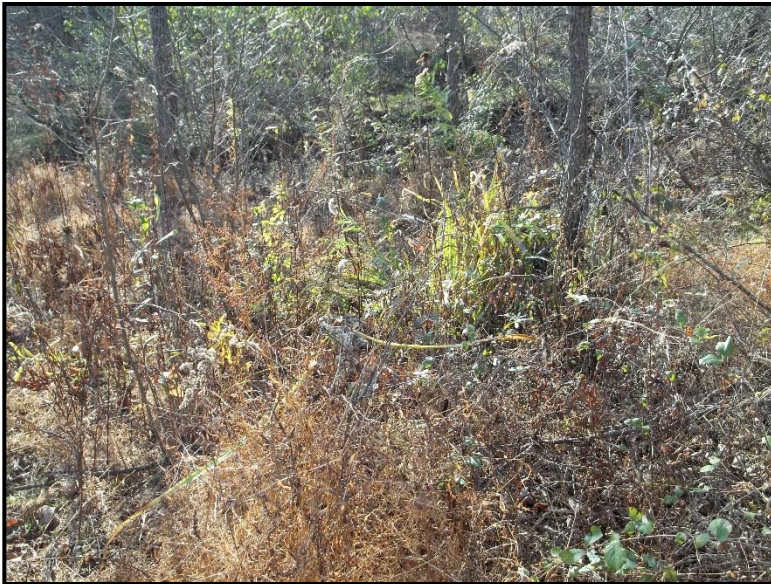
**Photo 2** (11-10-2014)

Wetland W2 is a palustrine forested/palustrine emergent (PFO/PEM) wetland complex in the floodplain on the east bank of Aires Run. Plot 3 is the hydric test plot representing the PFO community in Wetland W2. View is west.

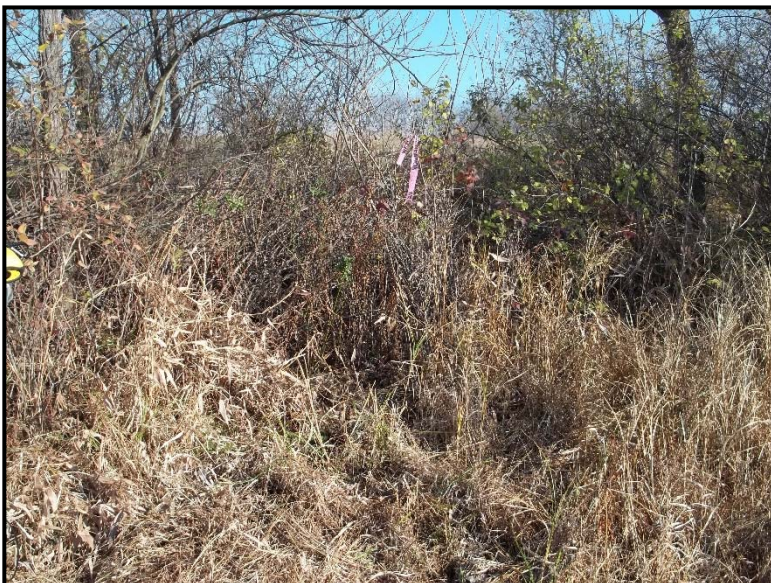
**Photo 3** (11-10-2014)

Wetland W2 is palustrine forested/palustrine emergent (PFO/PEM) wetland complex located in the eastern floodplain of Aires Run. Plot 4 is the hydric test plot representing the PEM community in Wetland W2. View is east.

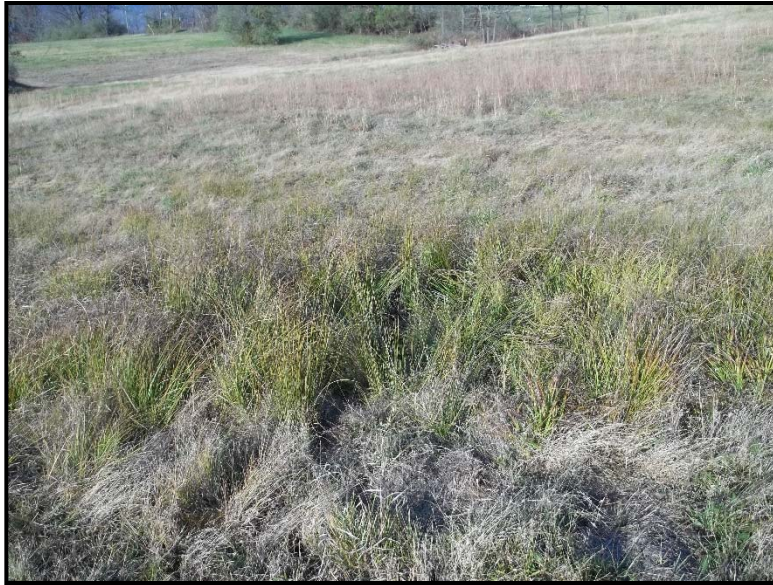
**Photo 4** (11-10-2014)  
Wetland W3 is a palustrine emergent (PEM) wetland located in a depression downslope of Wetland W1. Plot 2 is the hydric test plot for this wetland. View is north.

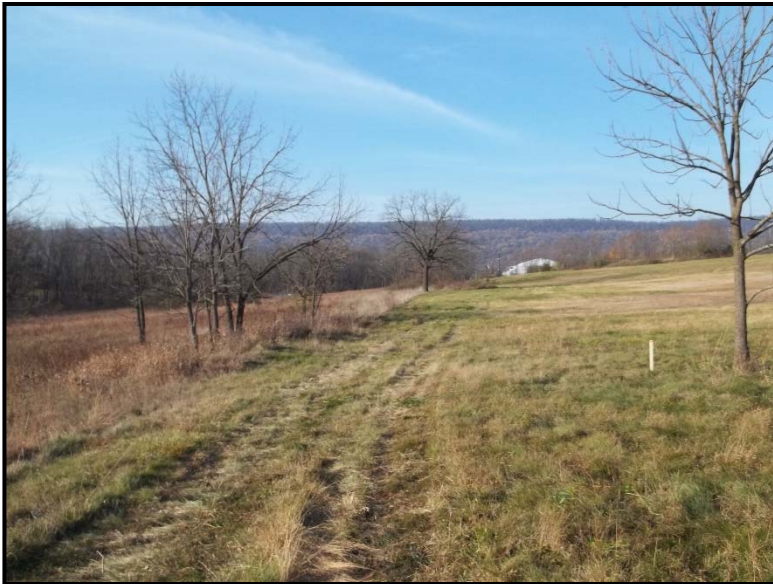
**Photo 5** (11-10-2014)  
The dominant land cover type within the project study area is fallow field. Plot 5 is upland test plot located near Plot 4 (Wetland W2). View is north.

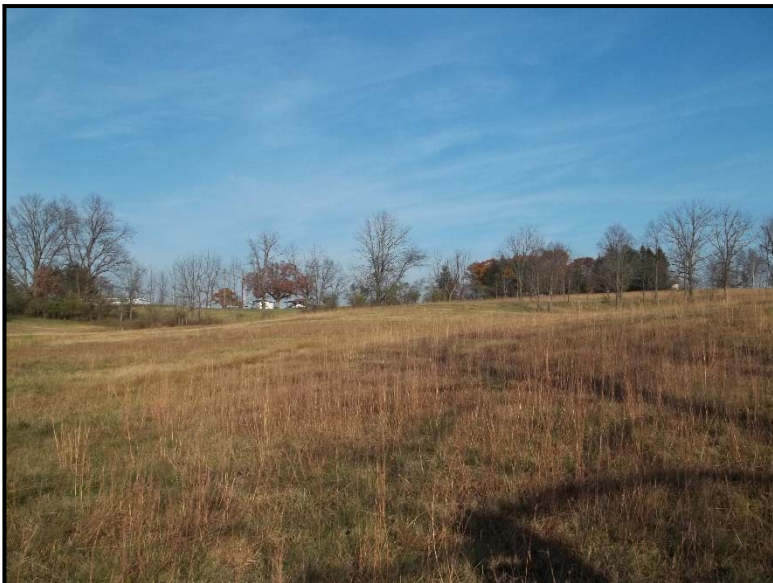
**Photo 6** (11-10-2014)  
The fallow field was dominated by mowed grasses, broomsedge bluestem (*Andropogon virginicus*), common plantain (*Plantago major*), English plantain (*Plantago lanceolata*), white clover (*Trifolium repens*), lesser hop trefoil (*Trifolium dubium*), and yarrow (*Achillea millefolium*). View is east.

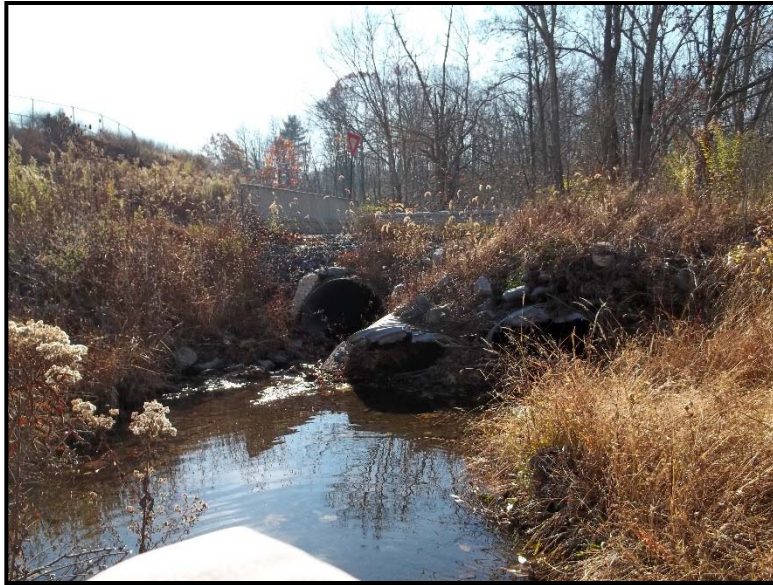
**Photo 7** (11-10-2014)  
Stream S1 is a perennial watercourse that provided the western boundary of the project study area. View is of the downstream end of Stream S1 at a culvert under Coulter Road. View is south.

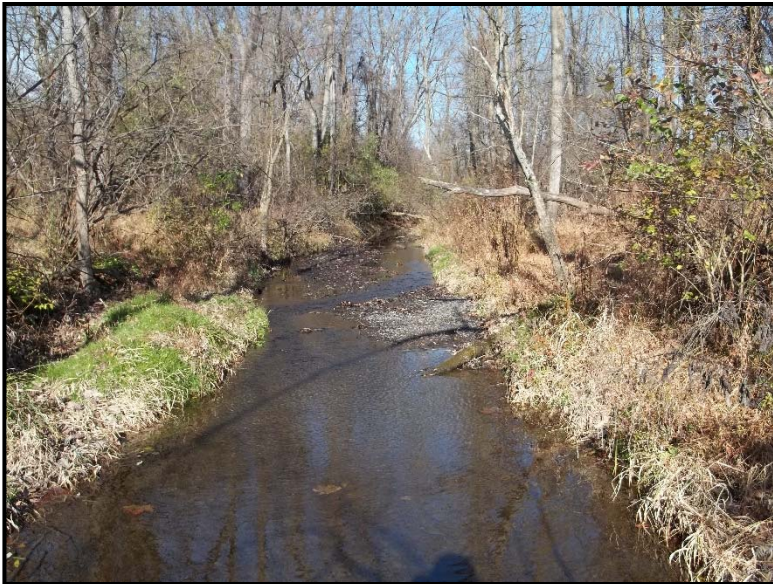
**Photo 8** (11-10-2014)  
View of Stream S1 looking upstream from Flag S1-4. The stream bank on the right is within project study area boundary, and the stream bank on the left is off site. View is north.

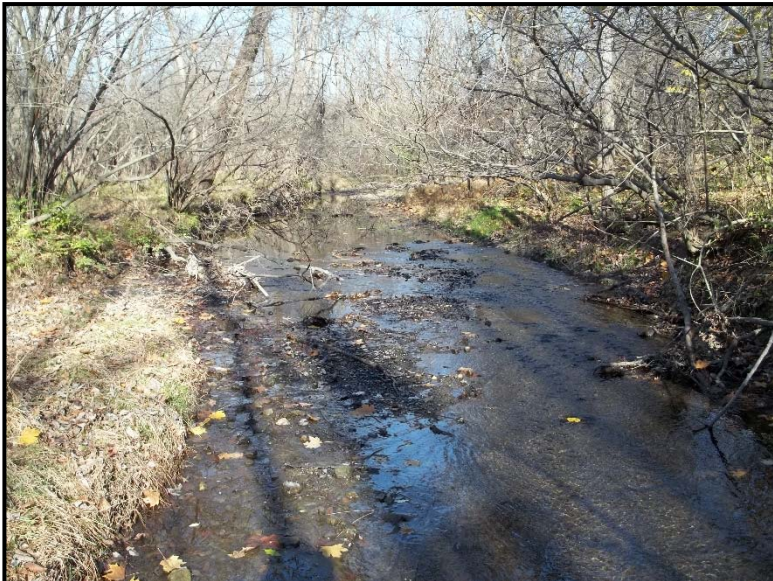
**Photo 9** (11-10-2014)  
View of Stream S1 looking upstream from Flag S1-21. The stream bank on the right is within project study area boundary, and the stream bank on the left is off site. View is north.

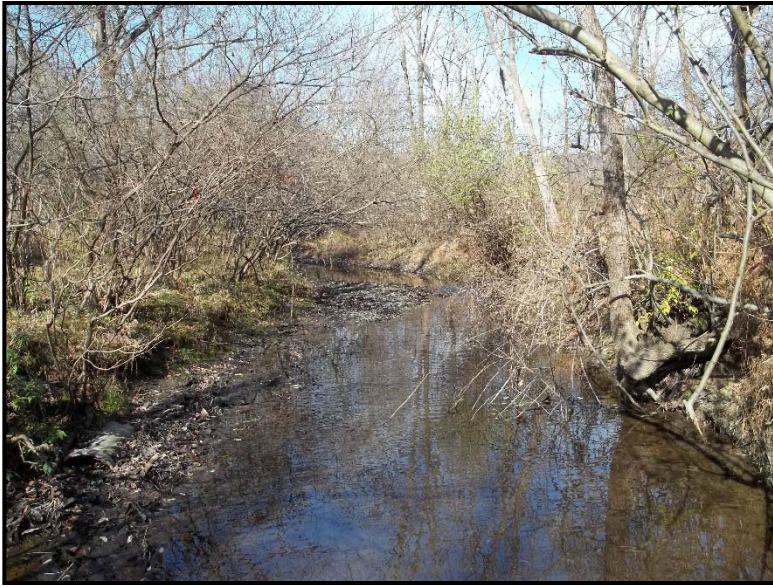
**Photo 10** (11-10-2014)  
View of Stream S1 looking upstream from Flag S1-31. The stream bank on the right is within project study area boundary, and the stream bank on the left is off site. View is north.

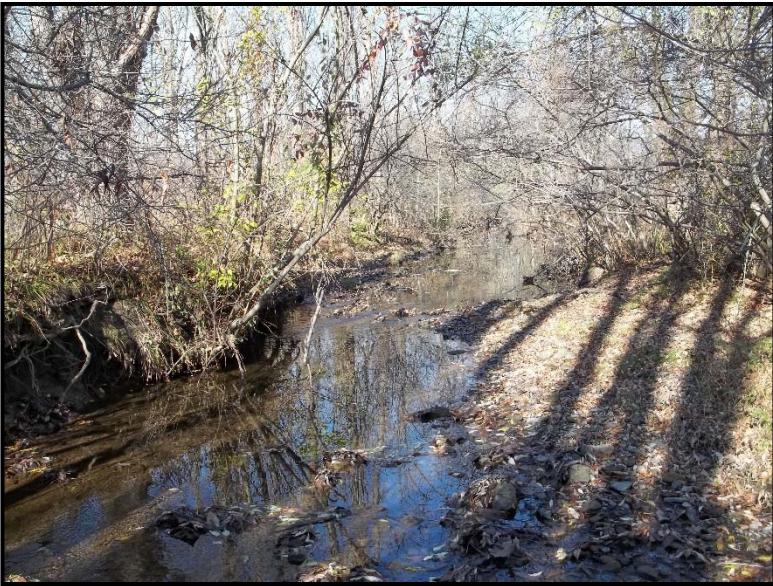
**Photo 11** (11-10-2014)  
View of Stream S1 looking upstream from Flag S1-43. The stream bank on the right is within project study area boundary, and the stream bank on the left is off site. View is north.

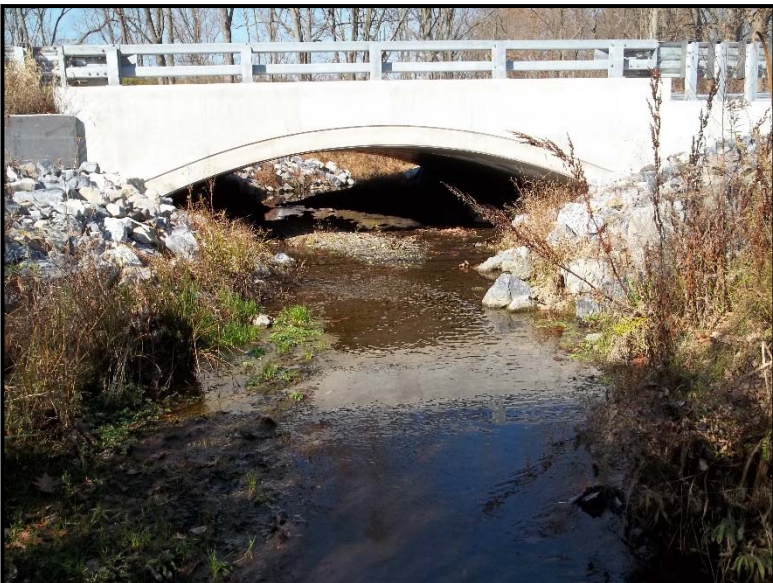
**Photo 12** (11-10-2014)  
Upstream view of Stream S1 (Aires Run) as it flow into the project study area beneath Service Road. The stream bank on the right is within project study area boundary, and the stream bank on the left is off site. The bridge is the northwestern corner of the project study area boundary. View is north from Flag S1-68.

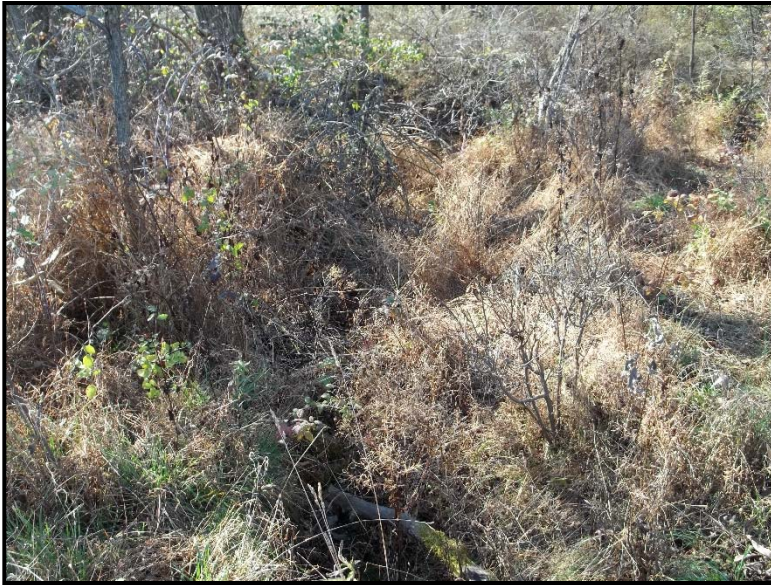
**Photo 13** (11-10-2014)  
Stream S2 is an ephemeral watercourse that drains Wetland W2 to Stream S1 (Aires Run). View is downstream from Flag S2-2 and west.

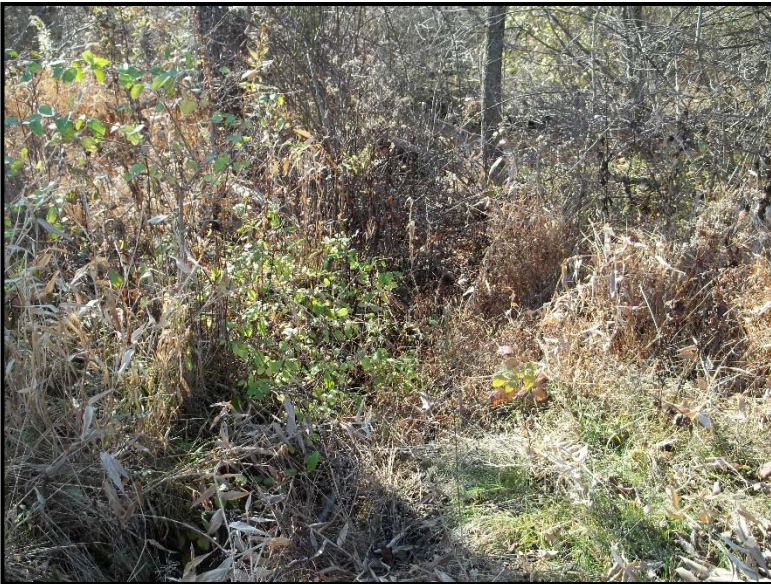
**Photo 14** (11-10-2014)  
Stream S3 is an ephemeral watercourse that drains Wetland W2 to Stream S1 (Aires Run). View is downstream from Flag S3-1 and west.

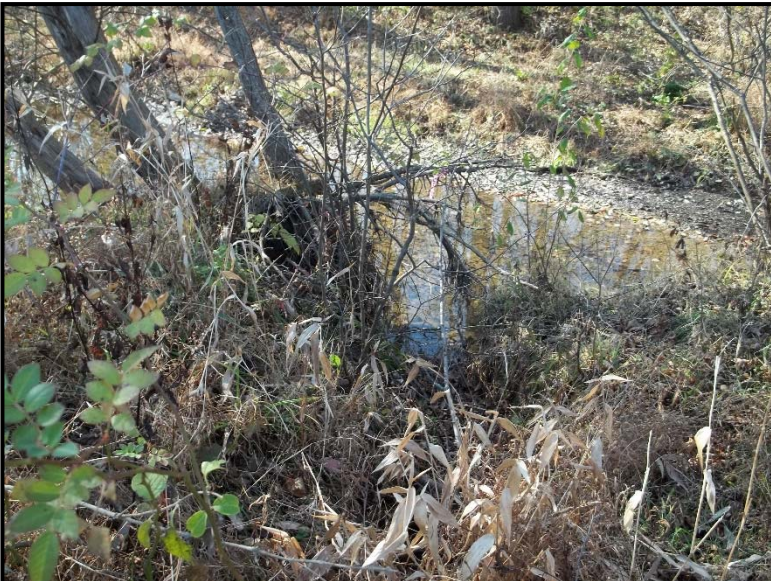
**Photo 15** (11-10-2014)  
Stream S4 is an ephemeral watercourse that drains Wetland W2 to Stream S1 (Aires Run). View is downstream from Flag S2-1 and west.

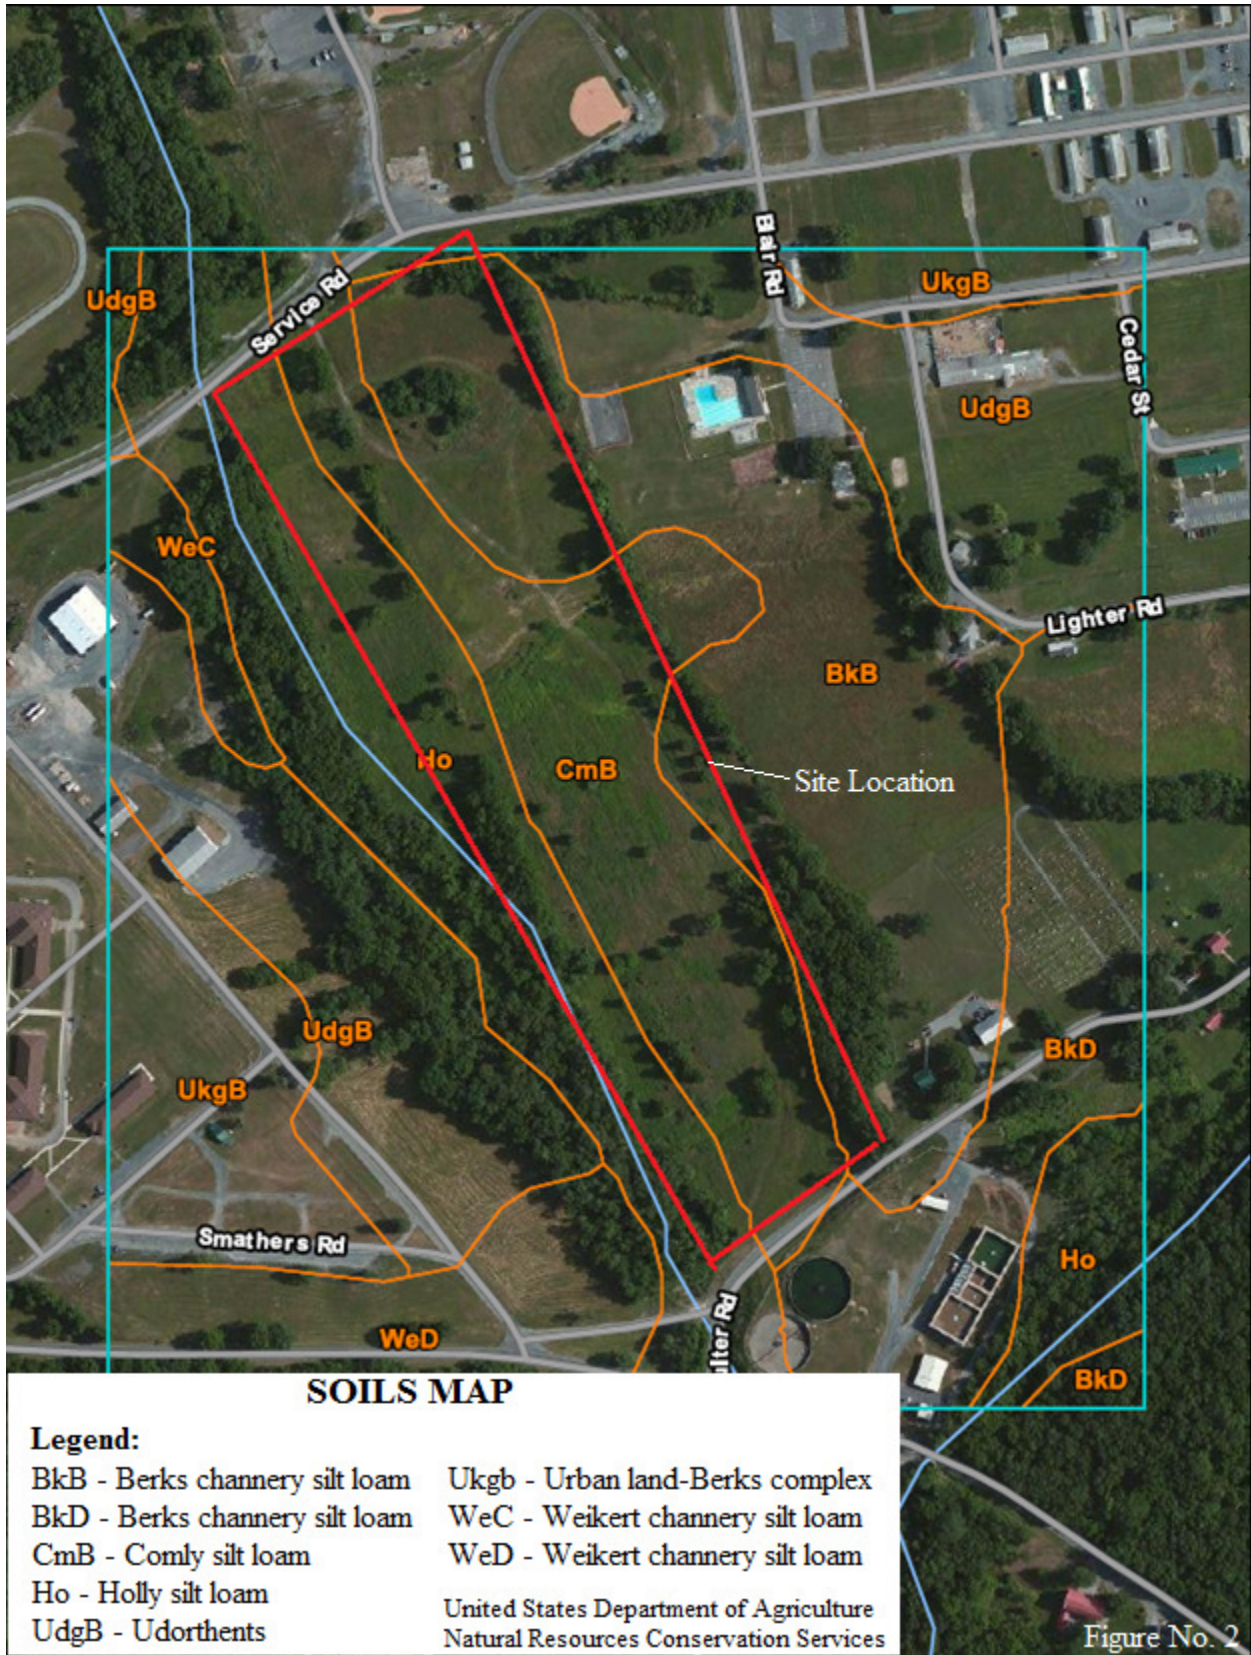
*Figure 2: Soils Map*

According to the USDA, National Resource Conservation Services (NRCS) of Lebanon County, Pennsylvania, the soils present at the project site are identified as Berks (BkB), Comly (CmB), and Holly (Ho) soils. A Soils Map is included in Figure 2.

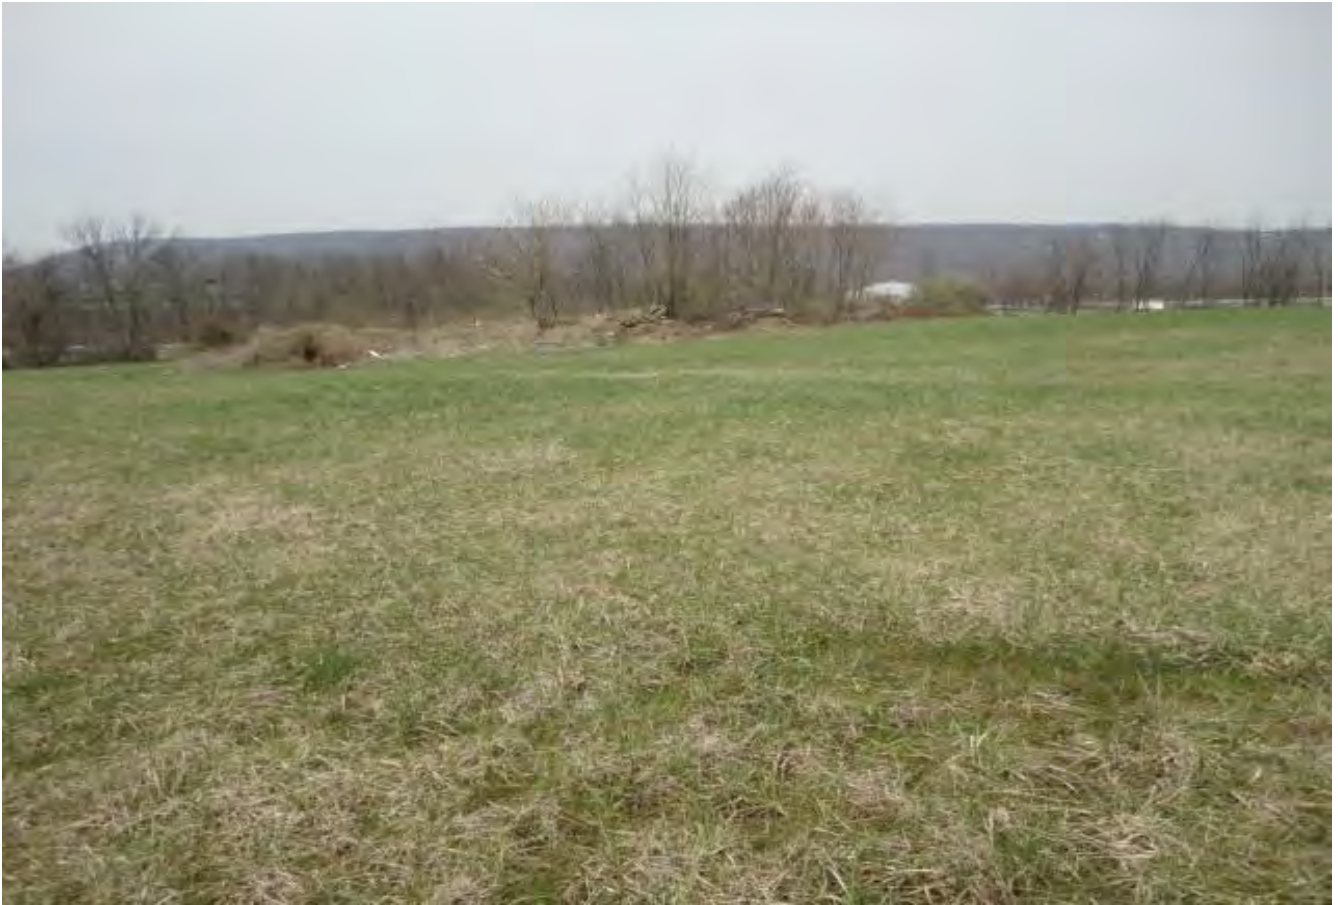
Photograph 1: View to the north of the debris pile near the Site's northern boundary.

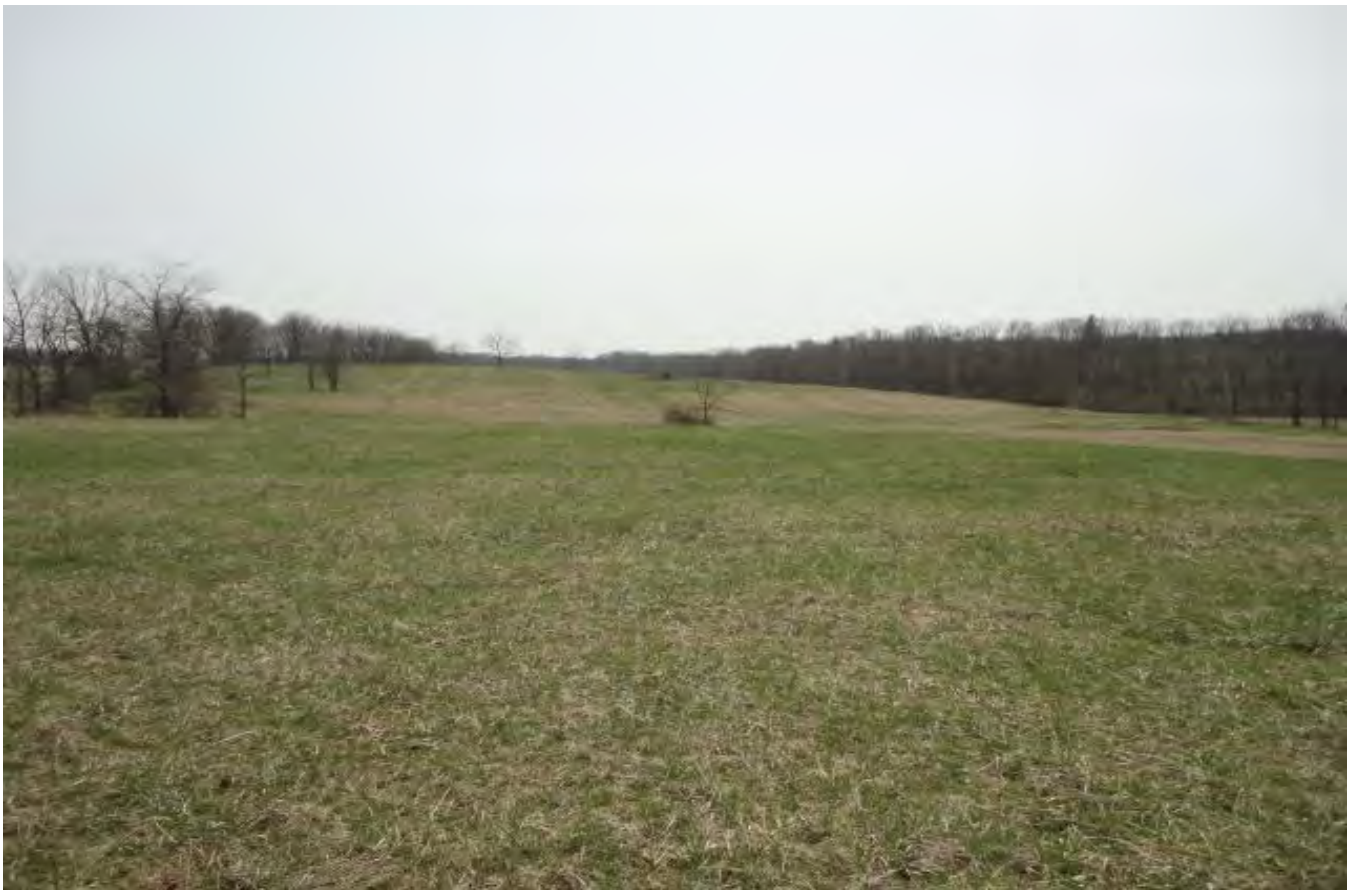
Photograph 2: View to the south of the Site's general condition and topography.

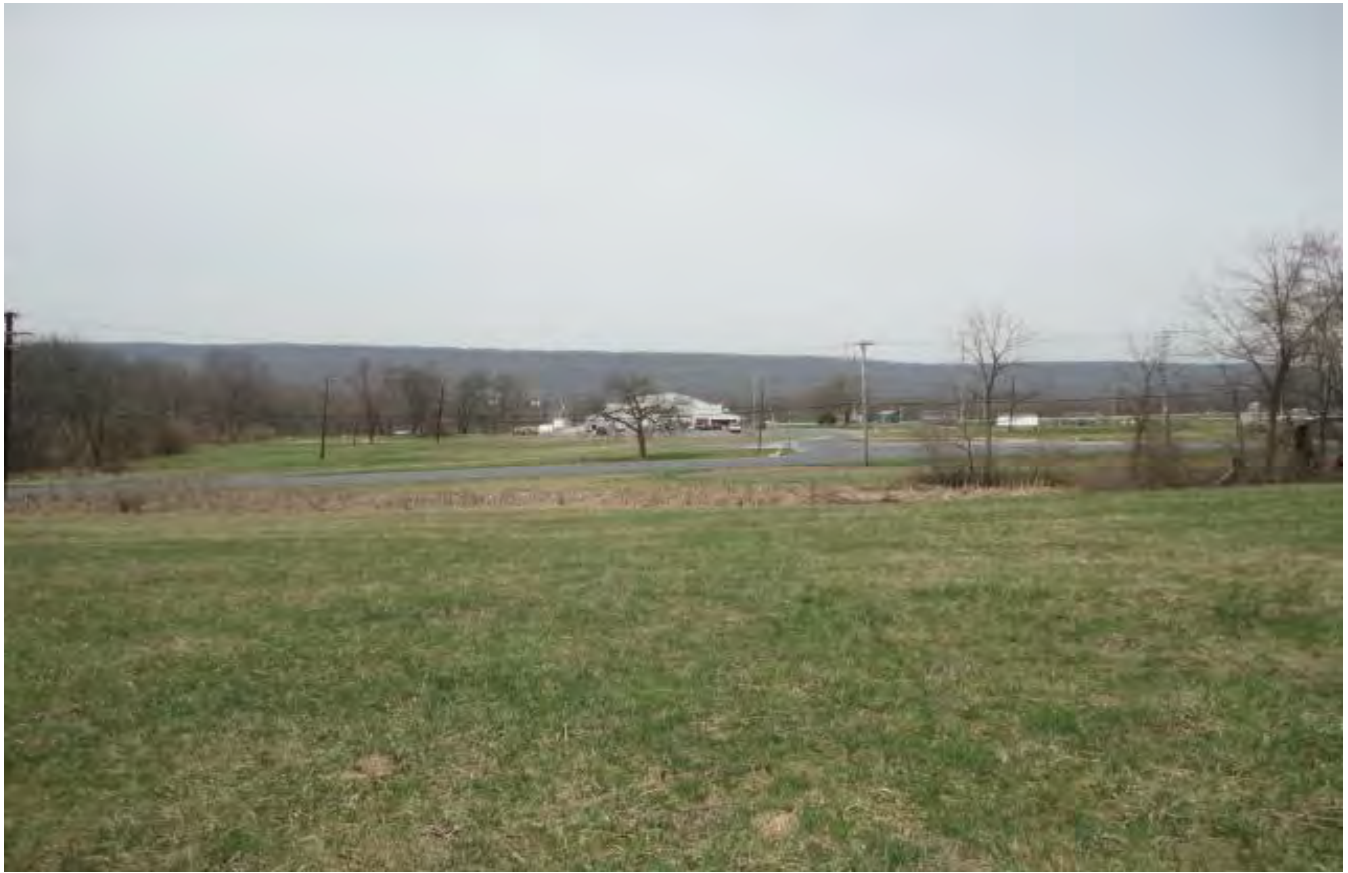
Photograph 3: View to the north of a small offsite wetland and gymnasium adjacent to Service Road.

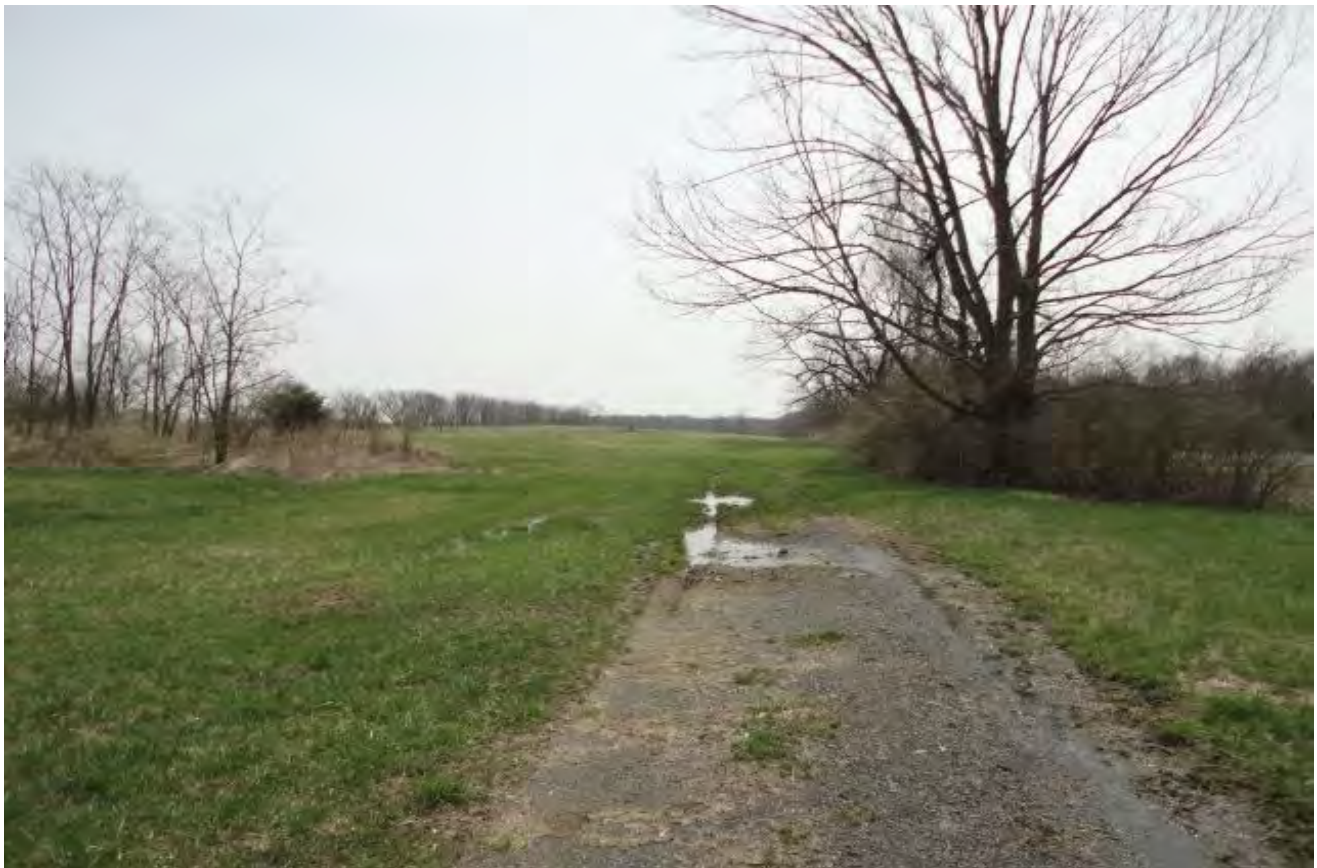
Photograph 4: View (facing north) of the onsite access road. A portion of the vegetated debris pile can be seen at the left of the photograph.

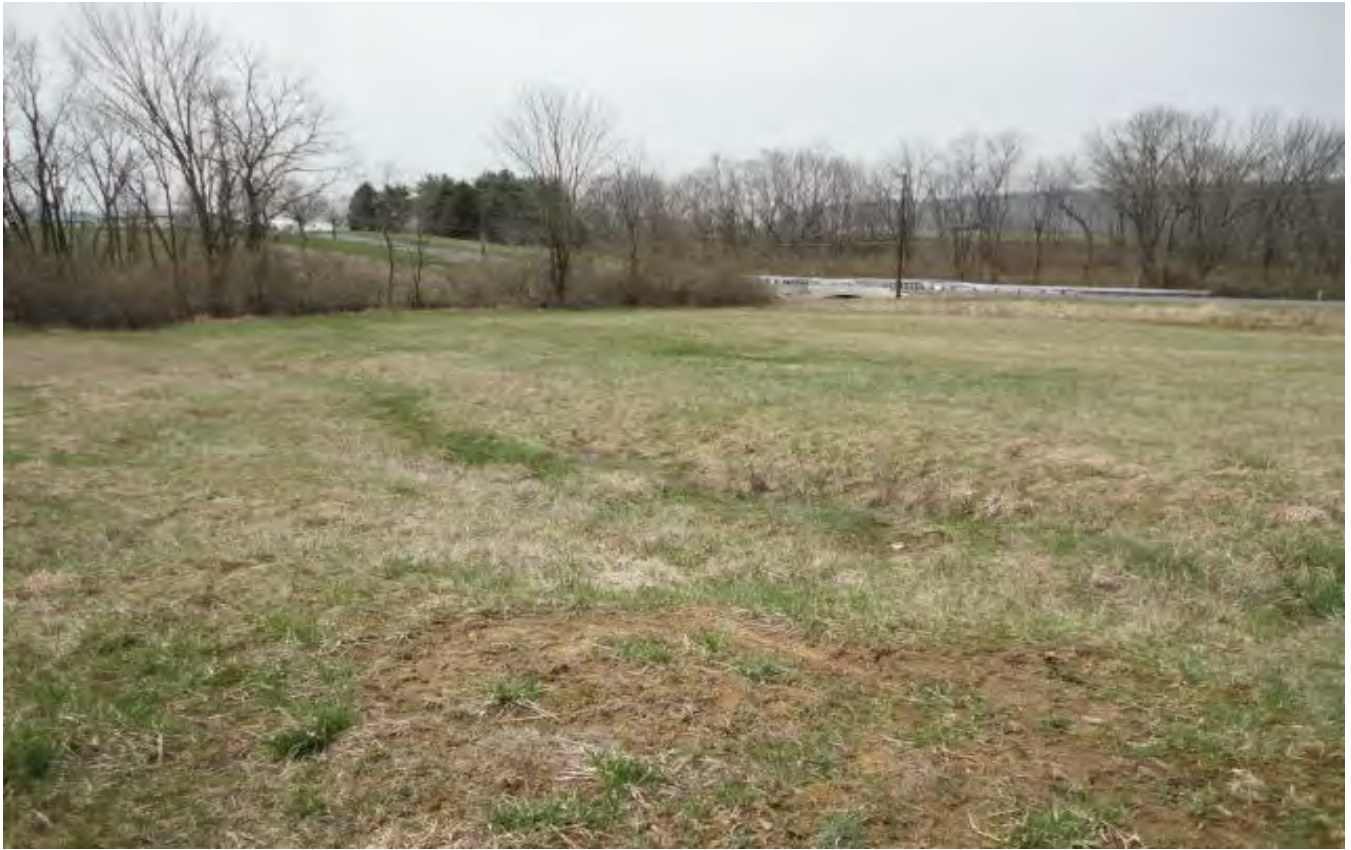
Photograph 5: View to the north of a shallow draining swale near the site's north side. Service Road can be seen in the background.

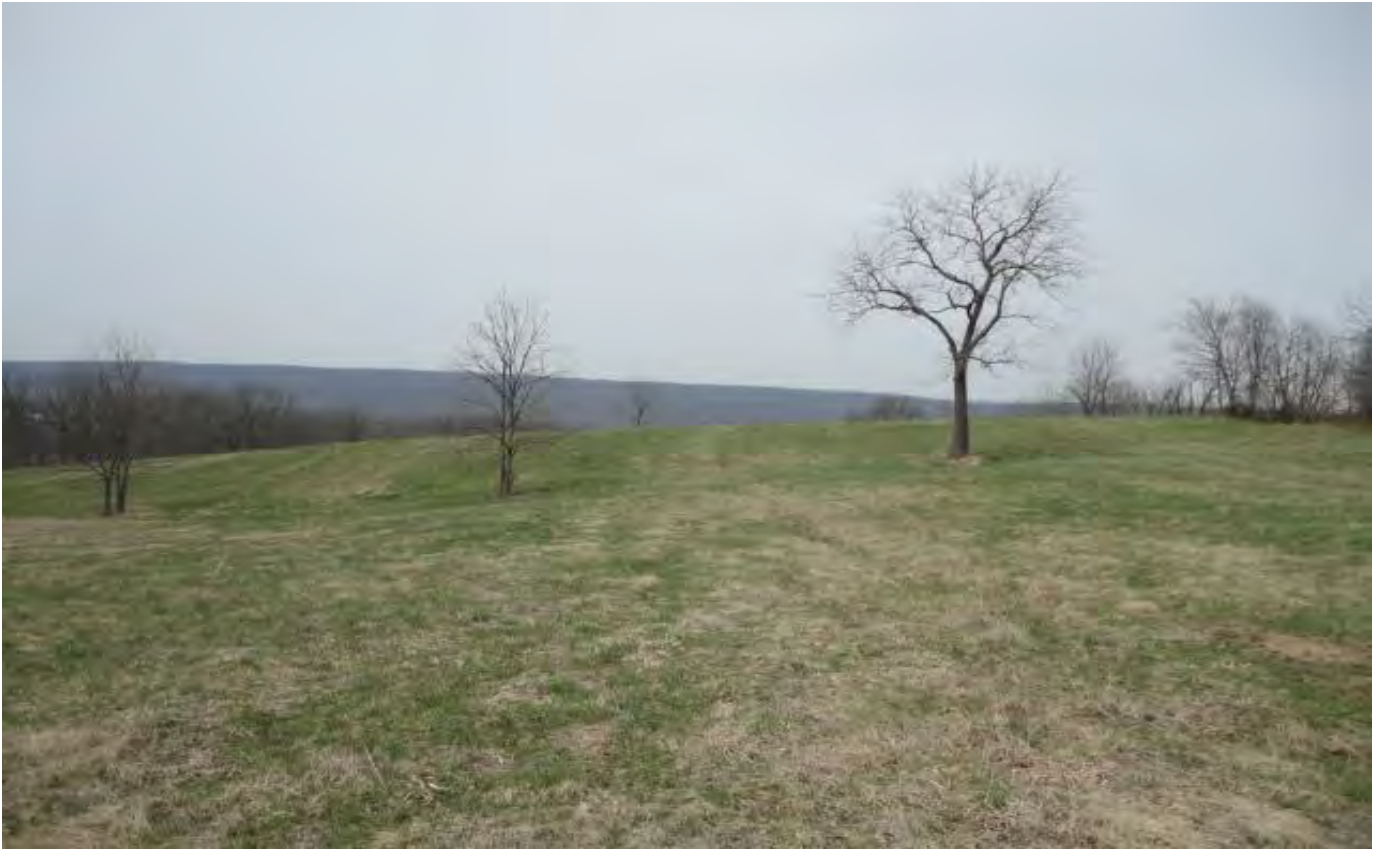
Photograph 7: View to the north from near the Site's central portion.

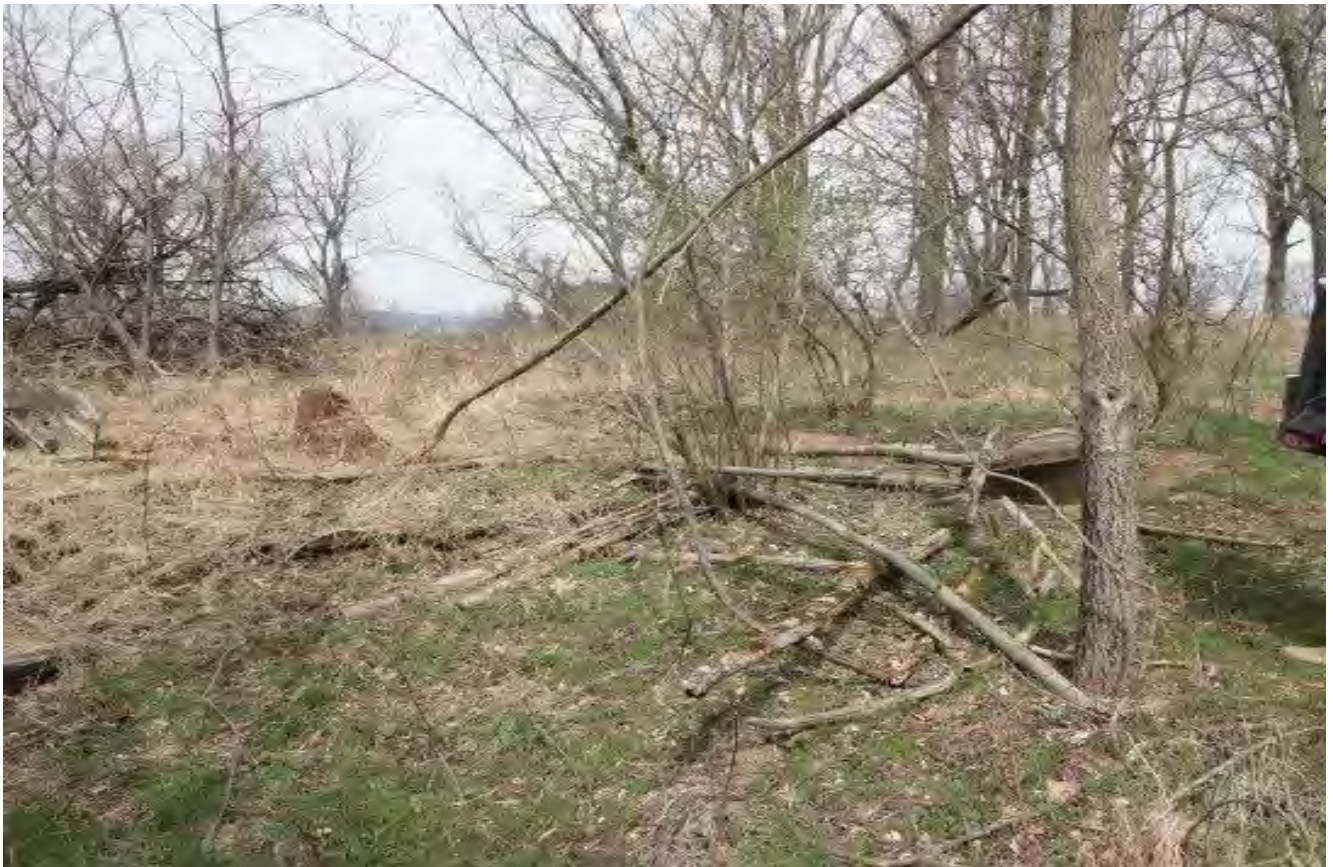
Photograph 10: View of the small building foundation observed near the Site's east side.

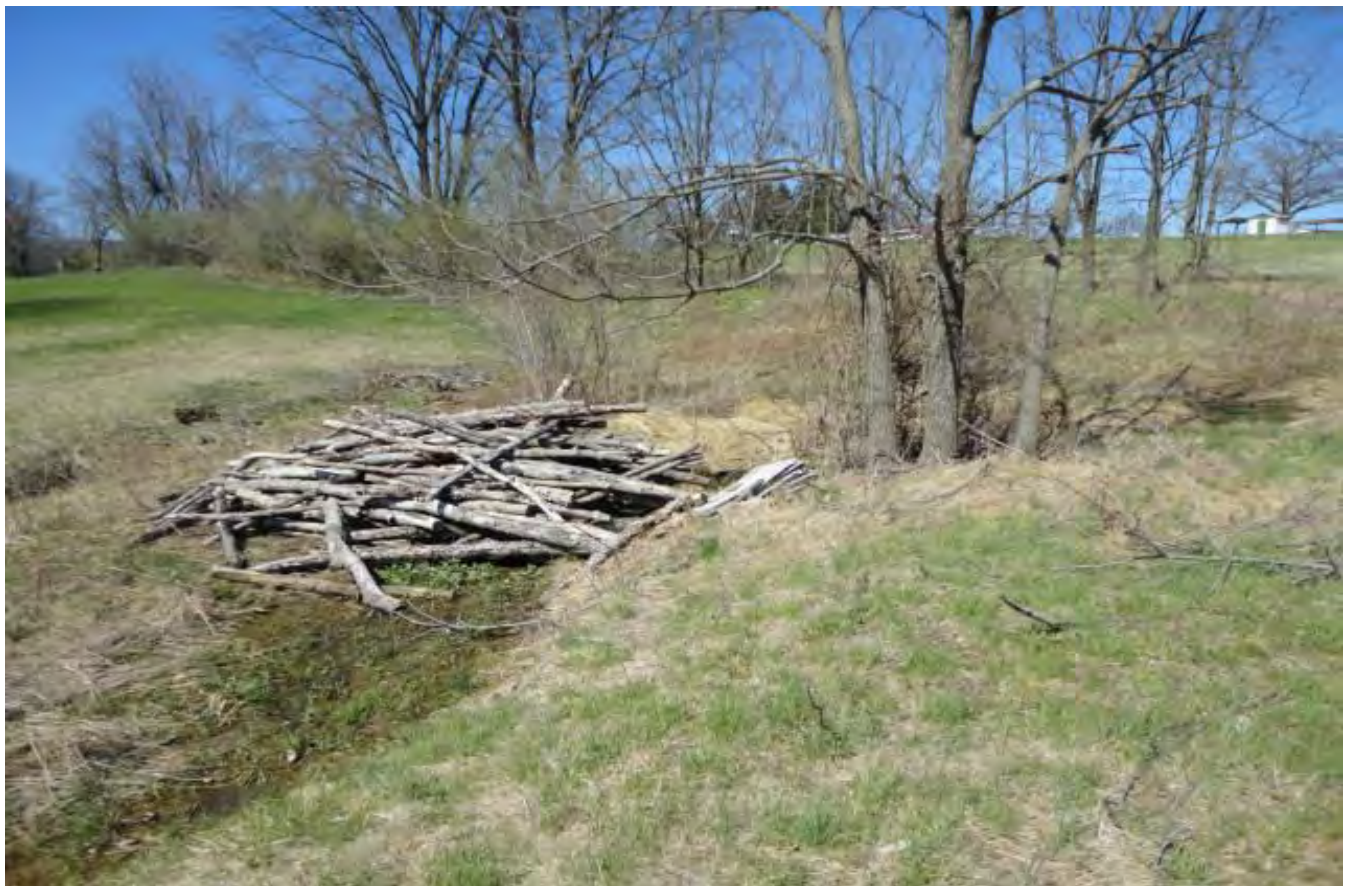
Photograph 12: View to the east of the apparent discharge point of the suspected spring/seep area along the Site's eastern boundary.
