**SITE DESCRIPTION/ SUITABILITY ASSESSMENT (SD/SA) REPORT**

**SOLAR PHOTO-VOLTAIC SYSTEM/ POWER PURCHASE  
AGREEMENT FOR FORT INDIANTOWN GAP  
ANNVILLE, PENNSYLVANIA**

**GANFLEC**

**March 2015**

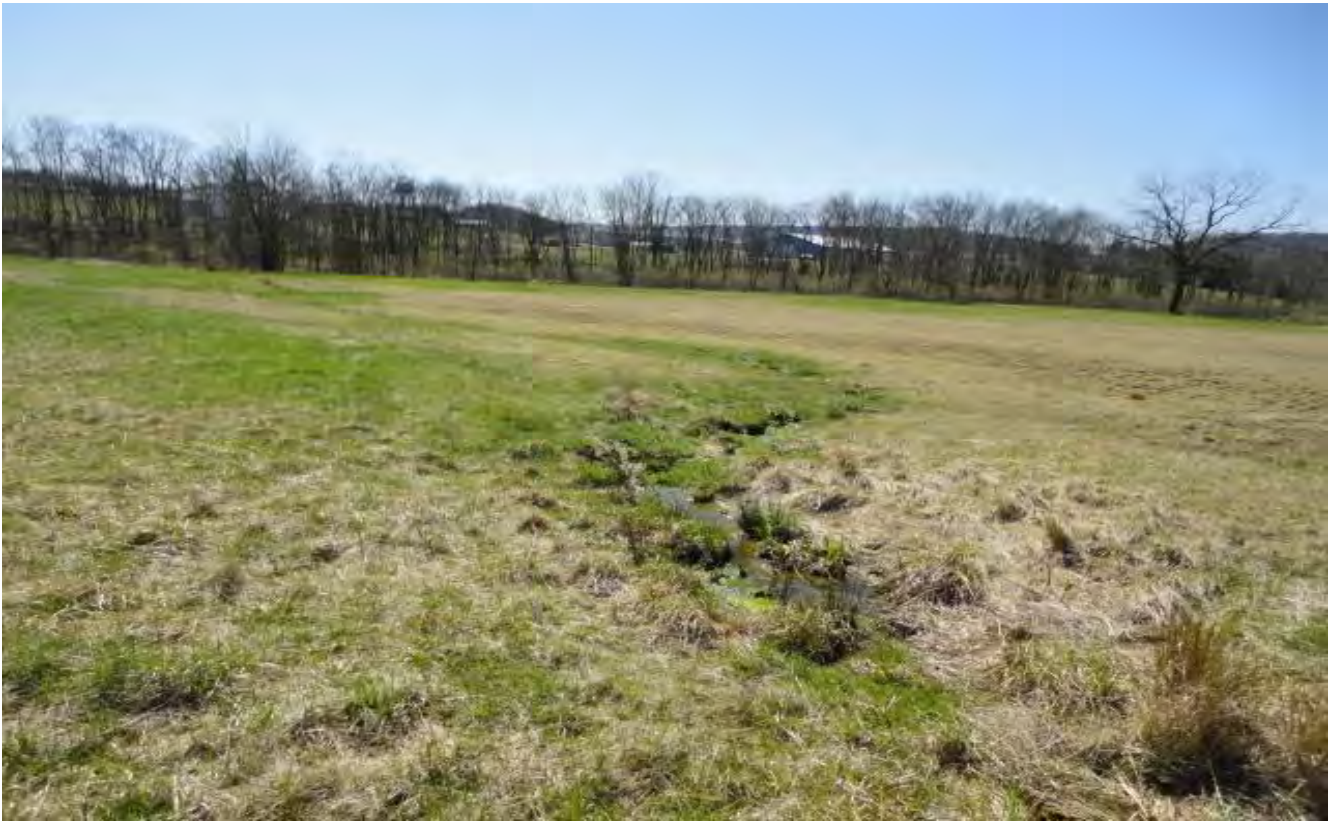
Photograph 13: View to the west of flowing water and the shallow drainage swale associated with the apparent spring/seep discharge.

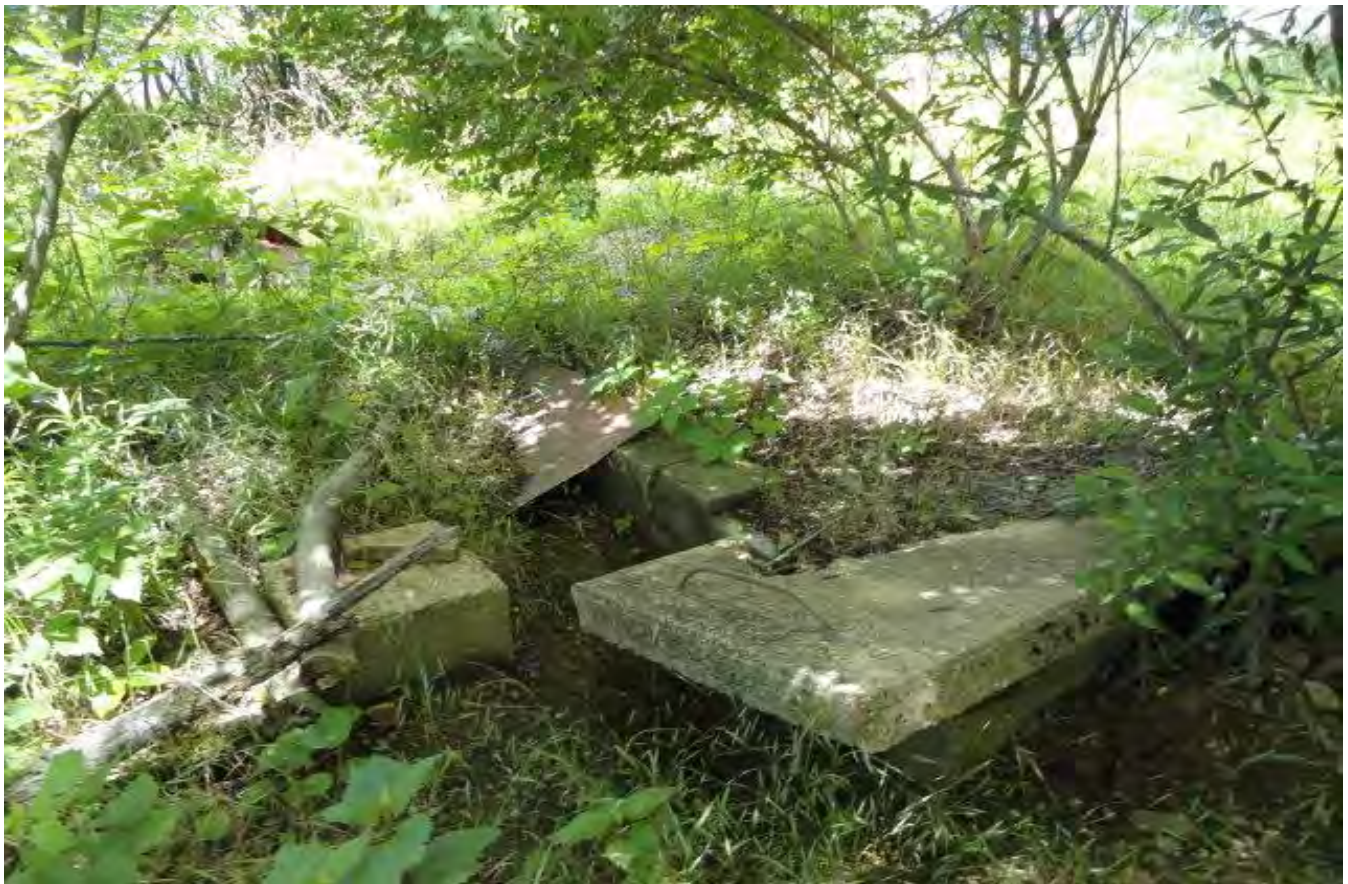
Photograph 14: View to the north of the old building foundation on the Site's east side.

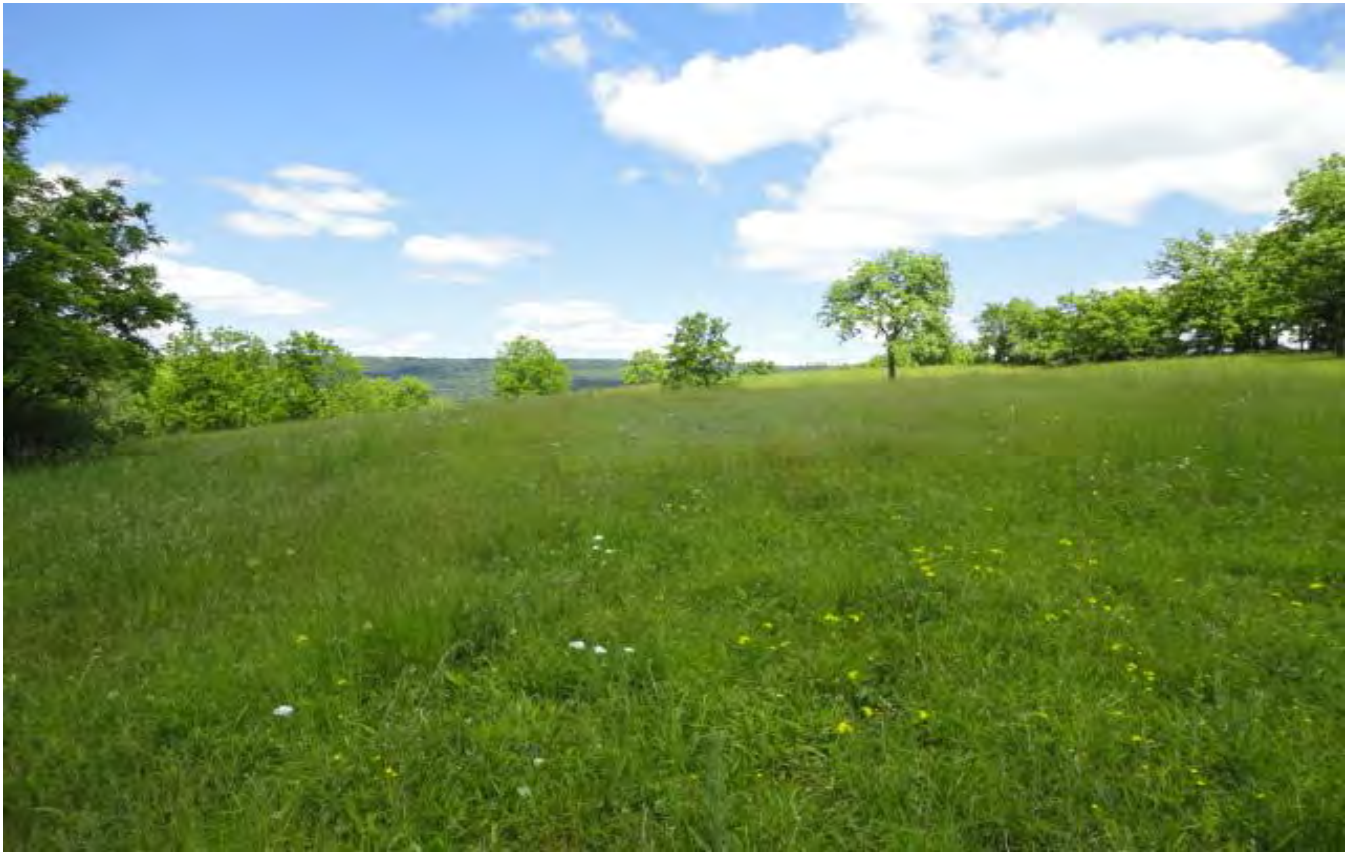
Photograph 15: View to the north of the approximate location of the former field latrine onsite.

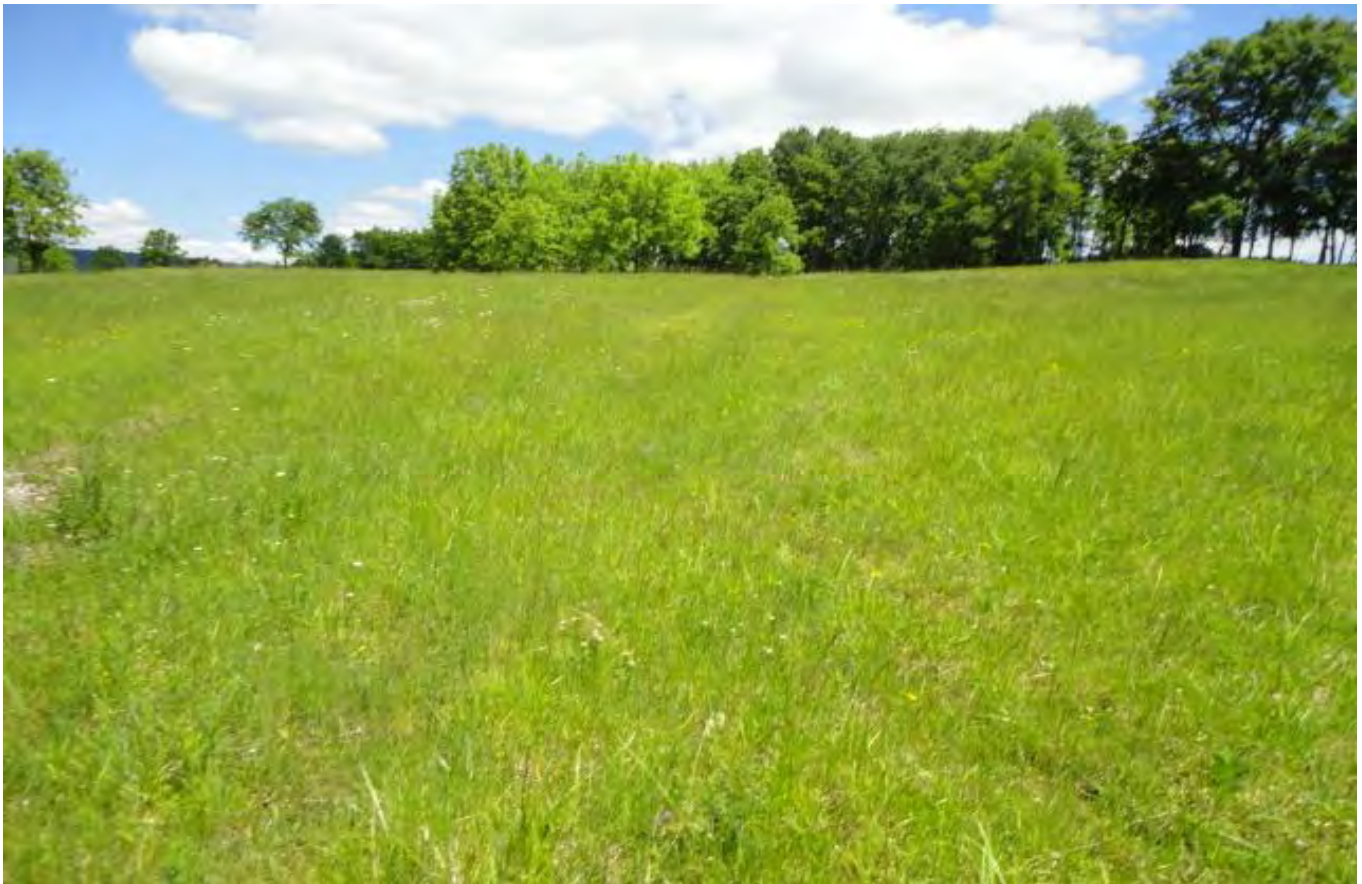
Photograph 16: View to the northeast approximately of part of the former access lane off Coulter Road.
